REPORT NO. RS-TR-66-5

**METALLURGICAL EXAMINATION OF BULLPUP "A"
PROPULSION UNIT S/N 4800 AFTER THREE YEARS OF STORAGE**

April 1966

**Materials Engineering and Development Branch
Structures and Mechanics Laboratory
Research and Development Directorate
U. S. Army Missile Command
Redstone Arsenal, Alabama 35809**

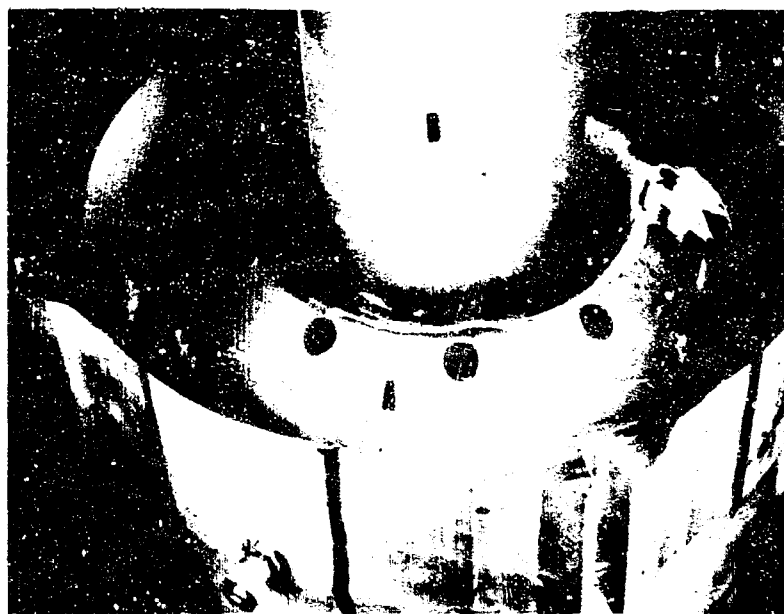
Figure 10. Deposits on Interior of Oxidizer Tank

Examination of the interior surfaces of the oxidizer tank revealed, in addition to the amber colored deposit, a slight etch condition over all surfaces. This etch was slightly more apparent at the weld heat affected zone (HAZ). The surface of the stainless steel SPGG diffuser and deflector was etched fairly heavily under the green flaky deposit.

- A. Stainless Steel Solid Propellant Gas Diffuser and Deflector
- B. Aluminum SPGG Tube
- C. Aluminum Oxidizer Tank Wall

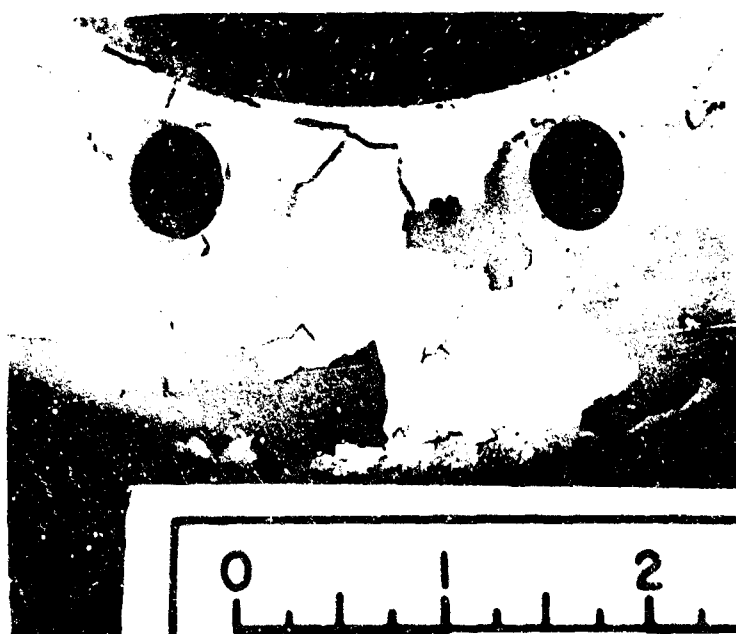
Figure 12. Deposit on Oxidizer Tank Solid
Propellant Gas Diffuser and Deflector

Residue found in the oxidizer tank was caused by a reaction between the stainless steel SPGG diffuser and deflector assembly and the IRFNA.

Deposit was lightly attached.

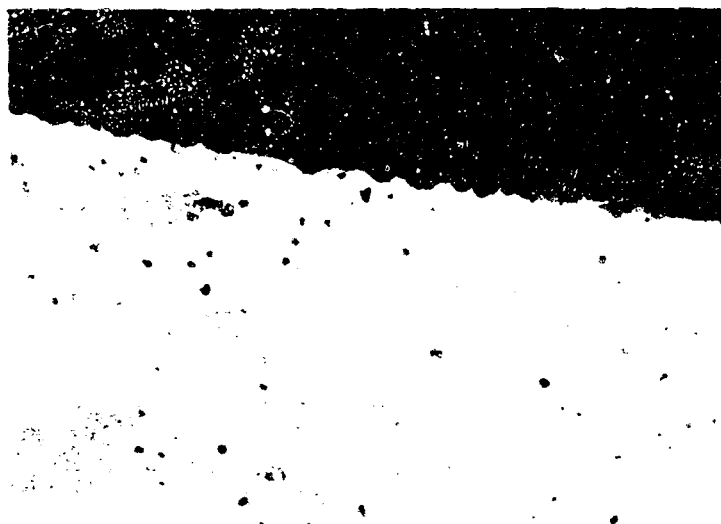
Figure 30. IRFNA Contact Surface of Aluminum Baffle HAZ at Stainless Steel SPGG Tube Weld

Degree of corrosion is the same in the HAZ of other aluminum components. Angularity of exposed grains does not appear to influence the amount of corrosion.

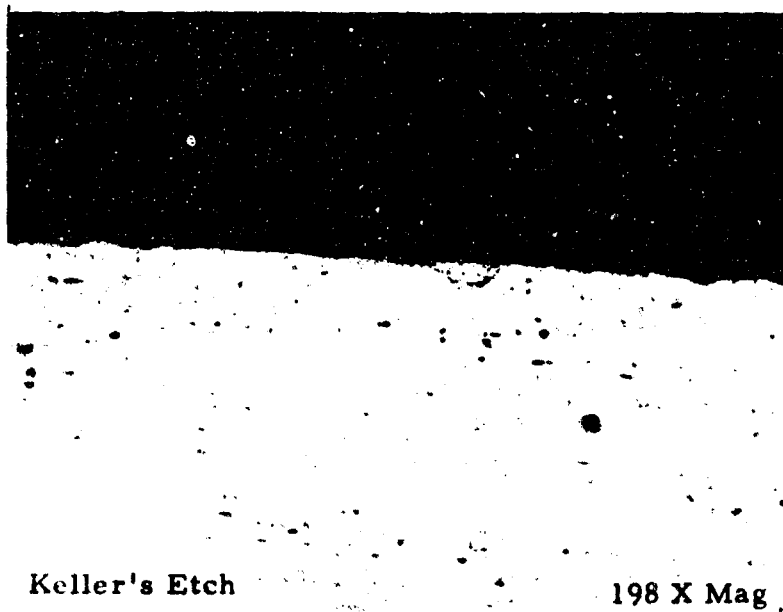
Figure 32. Interior Surface of Aluminum SPGG Tube That Had No IRFNA Contact

Surface generally free of attack.

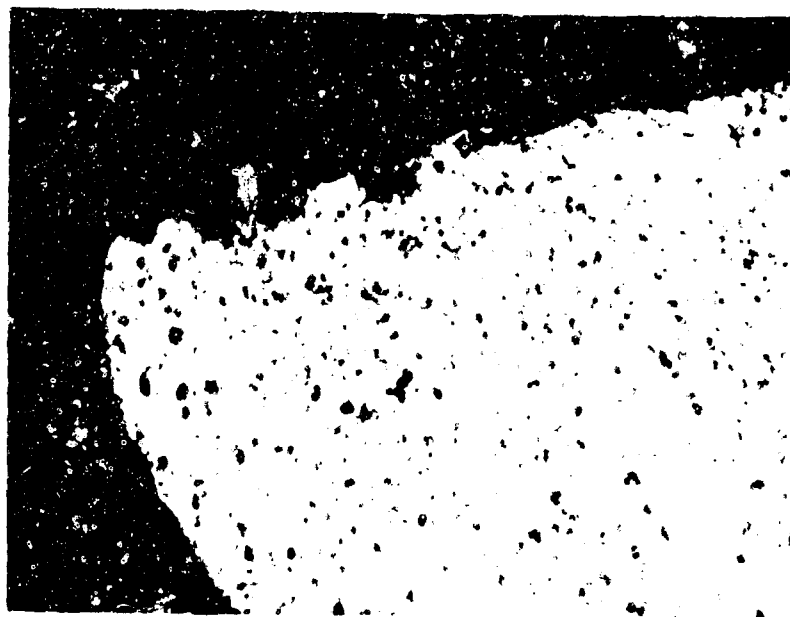
Figure 51. Corrosion on "Bucked" End of Rivet,
Oxidizer Director and Screen Assembly

Slight IRFNA attack apparent on heavily worked rivet [A].

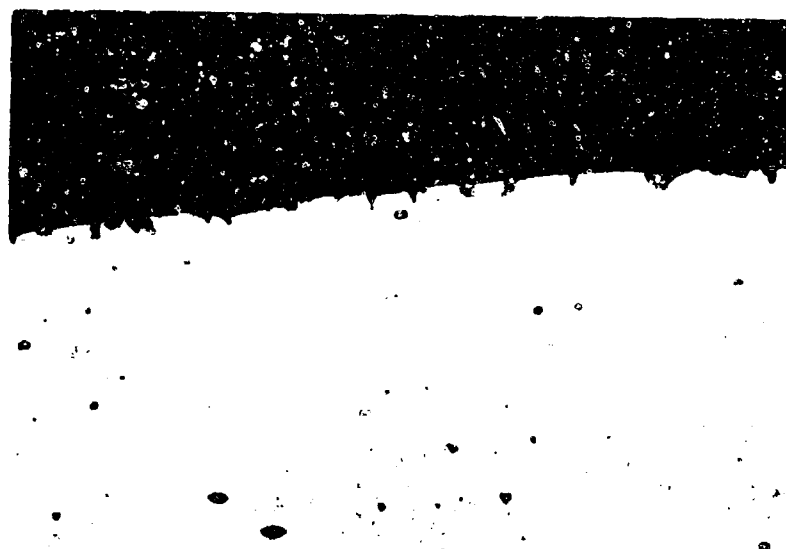
Figure 52. IRFNA Contact Surface, Stainless Steel
Screen

Electrolytic Oxalic Acid Etch 198 X Mag
Slight IRFNA attack is evident.

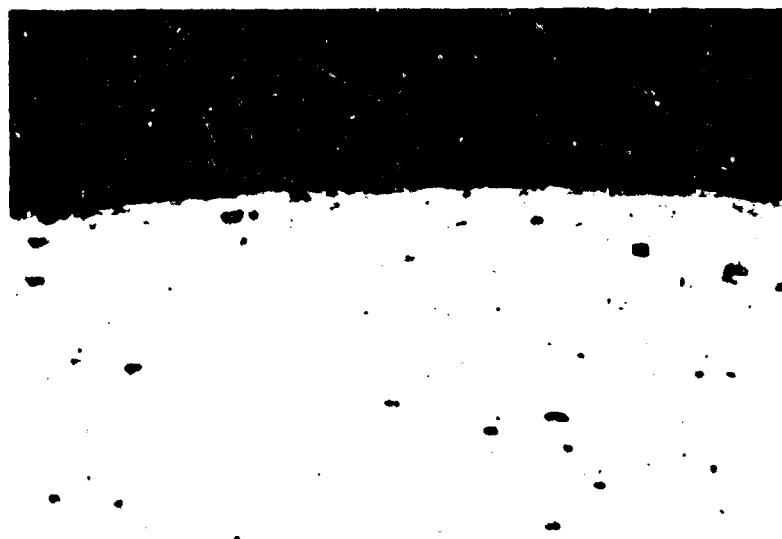
Figure 68. Stainless Steel Solid Propellant Gas Diffuser and Deflector, Microstructure

No corrosive attack is evident.
